MEASUREMENT OF POLYETHYLENE PIPE PARAMETERS DURING AN
OCEAN DEPLOYMENT

Final Report

FINAL REPORT

MEASUREMENT OF POLYETHYLENE PIPE PARAMETERS

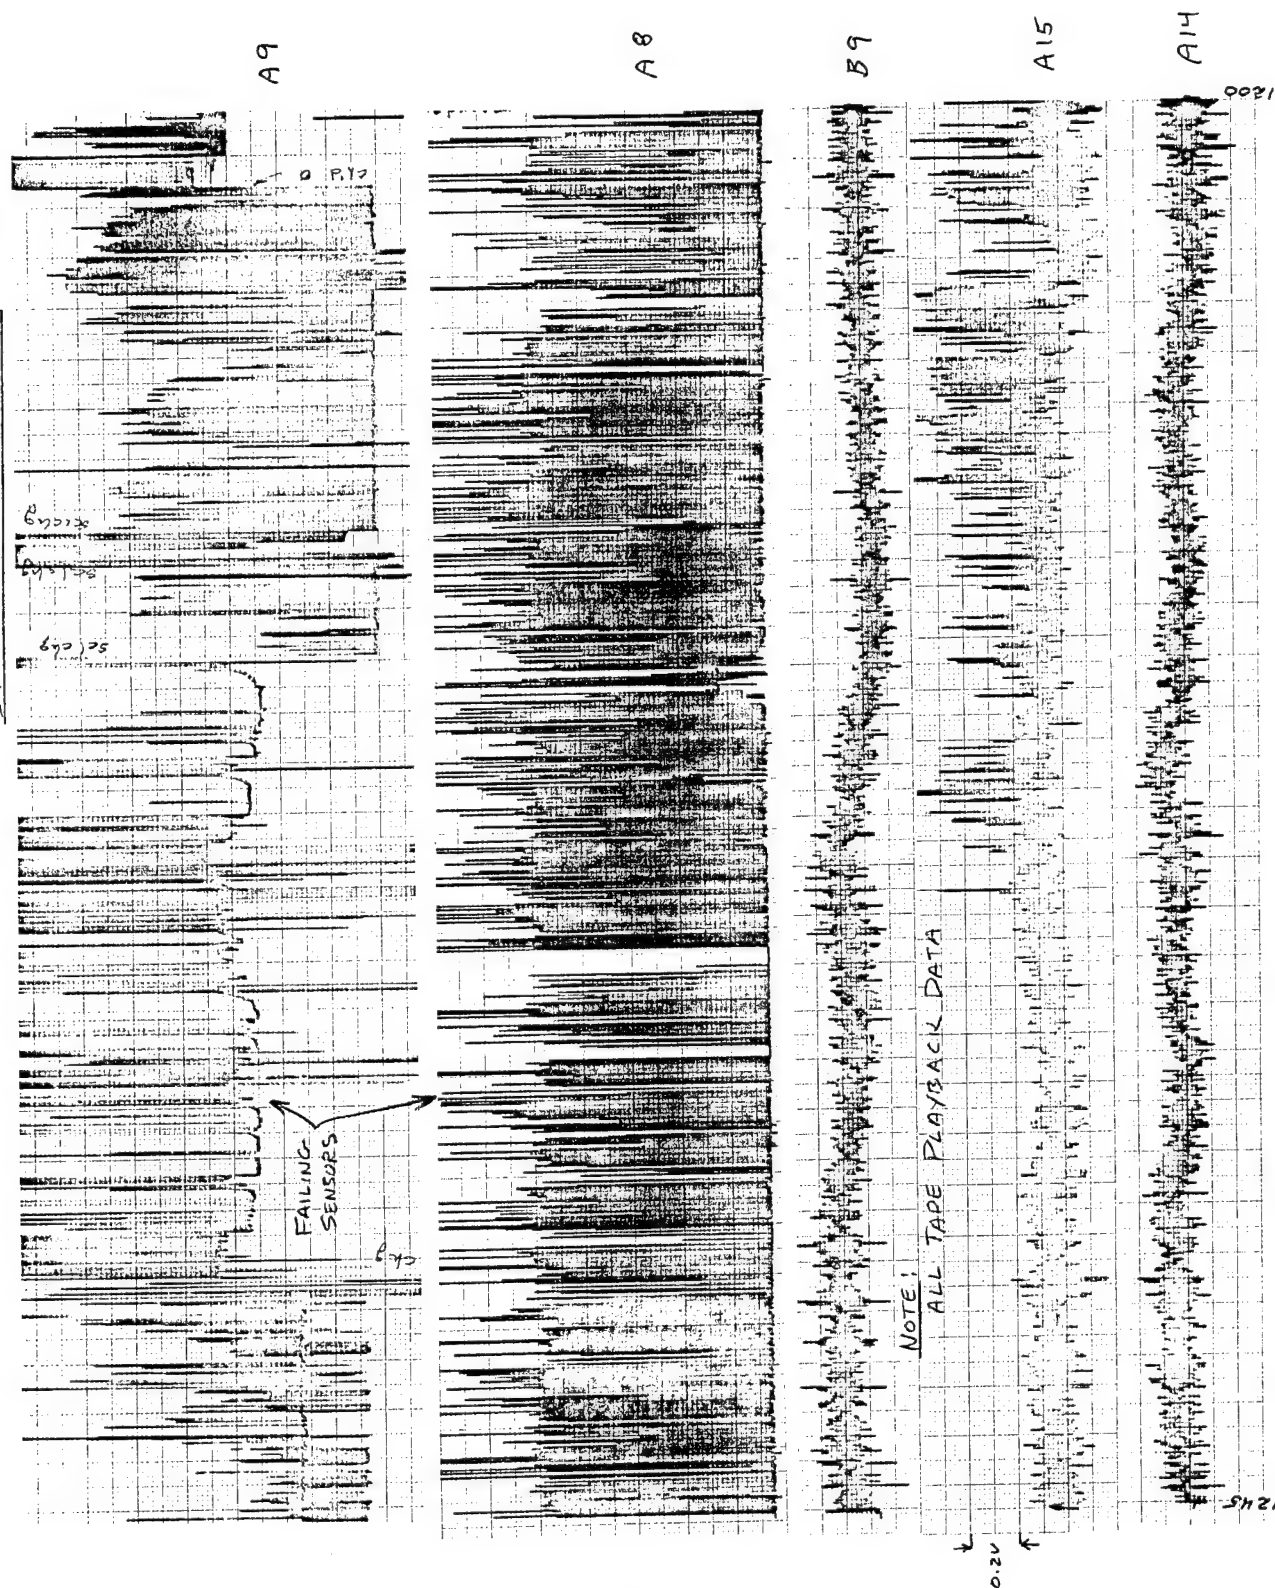
Figure 7- LVDT OUTPUTS

PIPE FLOODING

(NOTE: INCORRECT TIME READINGS - SEE TEXT)

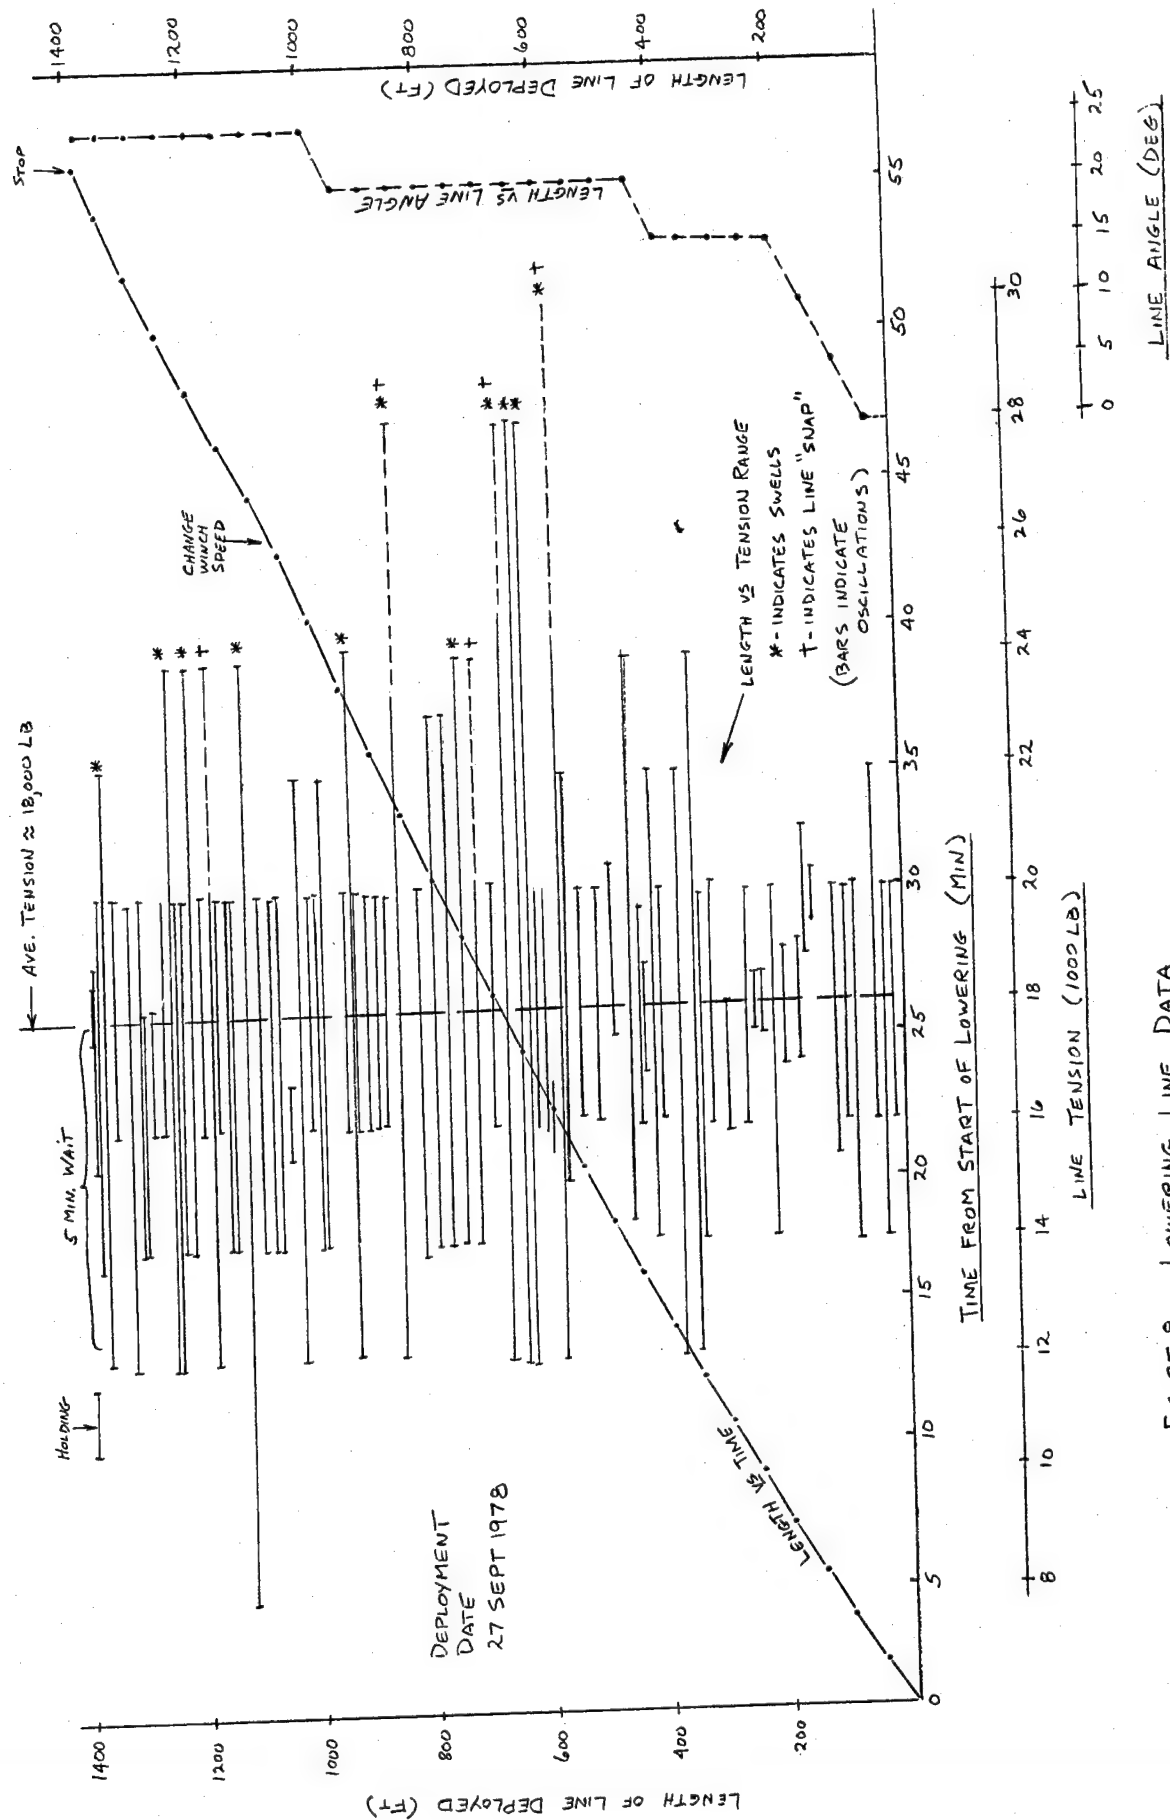
FIGURE 8 LOWERING LINE DATA

are presented in the chart of Figure 8 which shows tension, line angle, and time from start of lowering as functions of length of line deployed. It is seen that the average values of tension held at around 17,000-18,000 lbs. during most of the one-hour lowering operation. Variations were generally on the order of $\pm 2,000$ lbs. with a few larger variations of up to $\pm 10,000$ lbs. observed with passage of unusually large swells or with "jumping" or slipping of individual cable turns on the payout drum. Fluctuation periods of two seconds were "typical". The transient tension excursions observed had no detectable effect on the overall smoothness of the lowering operation. The final "holding" tension at the end of the payout, prior to cutting the lowering line to complete the upending operation, was $11,000 \pm 500$ lbs. Line angles (0° referenced to vertical) during the operation varied from 0° at the initial lowering, to a maximum value of 25° . The line angle rapidly reached $15^\circ - 20^\circ$ shortly after the start of the operation. There appears to be no clear correlation between tension and line angle but it could easily be masked by the transients in the tension data.
